WOOD FLOORING INSTALLATION GUIDELINES

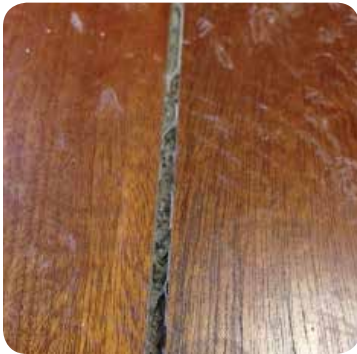
1. GAPS

Problem - Spaces that appear between individual boards.

- Wood flooring shrinks as it loses moisture
- The installer fails to properly seat a plank
- A floor is sanded before the adhesive has fully dried
- Environmental conditions

Solution - Use humidifiers & dehumidifiers to control humidity fluctuation.

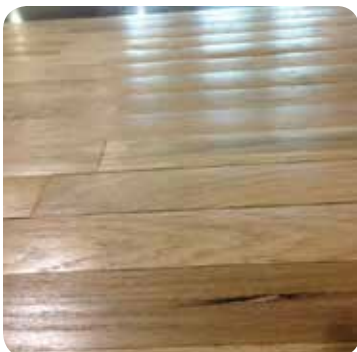
2. CROWNING

Problem - Crowning is where the center of the piece of flooring raises above the edges. This can be a temporary condition, and if the crowning is slight, the floor may remain well-anchored. The conditions persist only if there is a continuous source of moisture being introduced above or below the floor. Exposure to severe moisture levels, even for short periods of time, may also result in delamination of the flooring, or cracking or peeling of the surface finish.

- Continuous source of moisture being introduced above or below the floor
- Cupping had previously occurred, and flooring was sanded before the moisture content could return to normal

Solution - Allowing the wood to acclimate on site before it is installed serves to reduce the growth that occurs after installation, and reduces the potential for moisture related problems. Taking moisture readings on the top and bottom of the floor will allow moisture imbalance to be distinguished from unbalanced construction in the flooring. Once the moisture levels of the floor and subfloor have returned to normal, re-sand and finish.

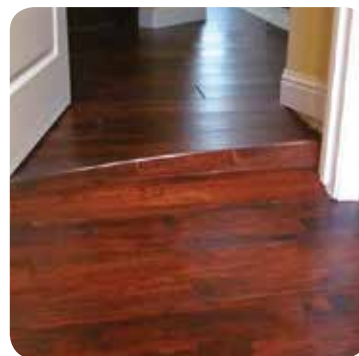
3. BUCKLING

Problem - Flooring parting from the subfloor due to extreme expansion caused by excessive moisture. When a floor buckles, there will often be several feet of flooring along the edge of the room which remain flat, followed by several adjoining rows of flooring which are uplifted in an inverted "V". The floor may show signs of rotting, and there may be mold or mildew present on the wood. When moisture has been introduced through a concrete slab, there also may be discoloration of some adhesive types, with a reddish or purple color developing in certain areas.

- Moisture changes in wood
- Moisture caused by leaking pipes, wet slabs, extreme humidity
- Use of wrong trowel
- Inadequate adhesive use
- Floor runs out of room to expand

Solution - Allowing the wood to acclimate on site before it is installed serves to reduce the growth which will occur after installation, and reduces the potential for moisture related problems. It is important to check the subfloor to verify that the moisture level is reasonable before beginning the job, and to observe the recommended flash times for any water containing adhesives to minimize the moisture they can contribute to the floor. Because many moisture-related problems result from poor drainage outside the building, it may sometimes be wise to recommend that gutters be installed or drainage improved before a large investment is made on a wood floor. For damaged floors, reverse the high-moisture situation and let the floor/subfloor dry. Relieve flooring of stress caused by vertical obstacles (cabinets, walls, etc.). Sometimes repair or individual replacement is possible, but often a complete replacement is necessary.

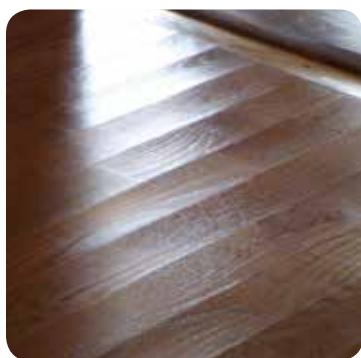
4. CUPPING

Problem - The edges of an affected piece of flooring rise above the center of the piece. This can be a temporary condition, and if the cupping is slight, the floor may remain well-anchored.

- Different moisture levels within individual layers of flooring
- Low levels of humidity (referred to as “dry cupping”)
- Rapid drying of floor surface

Solution - Allowing the wood to acclimate on site before it is installed serves to reduce the growth which will occur after installation, and reduces the potential for moisture related problems. Taking moisture readings on the top and bottom of the floor will allow moisture imbalance to be distinguished from unbalanced construction in the flooring. When the excessive moisture is removed, the flooring can return to its original shape, but it could take months. If it does not return to its original shape, the floor is probably permanently damaged and the edges that are cupped may be sanded off. Floors may also cup due to rapid drying, and in this case, it is recommended that humidification be used.

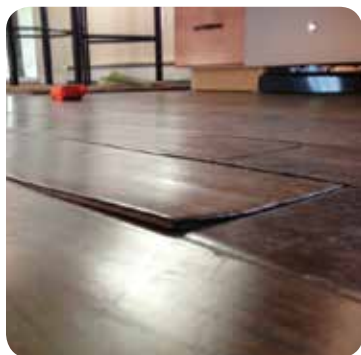
5. ENDLIFTING

Problem - Wood flooring boards look as if they are raised at the end.

- Incorrect maintenance
- Use of wrong trowel or adhesive
- Mistake during manufacturing
- Inadequate spacing of cleats or staples
- Excessive moisture during installation, adhesive not being able to dry

Solution - If the problems are related to excessive moisture, once the moisture is removed, the affected areas may be repaired.
